# Technical report on 100% hot-in-place asphalt recycling trial pavement

- Project Name: The Re-pavement Construction of Cheongan Samgeori-Cheongan Bridge on County Road Line 1 (Goesan County, Chungbuk, Korea)
- Scale of construction: 2,236.5 m<sup>2</sup> of road retreatment pavement
- Extensions and road width : L = 355 m, W = 6.3 m
- Thickness of pavement : T = 15 cm (base 10 cm + surface 5 cm)

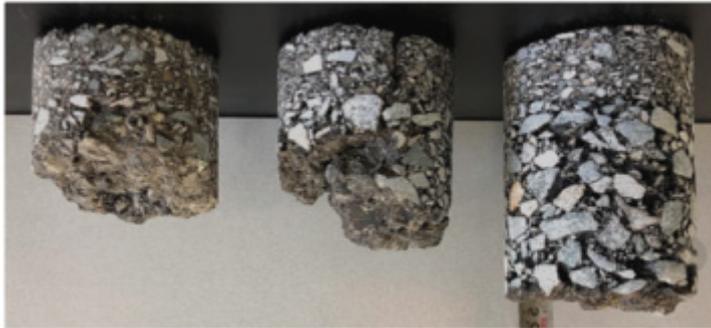
- Permanent Deformation: Weak deformation of about 2~3 cm, Deposition of substrate and decrease of bearing capacity
- Fatigue Crack: Serious cracks have been carried out due to reduced bearing capacity of the base and long

fatigue loads, from the bottom of the pavement to the surface layer

- Wear, Labeling: Progress of typical pavement aging with long-term public use
- Basement Loss: Long term load transfer and moisture penetration break the binding force of the base mixture and lose some of the base mixture in the area of the wheel

**Fig. 4.** Field Cores before Construction

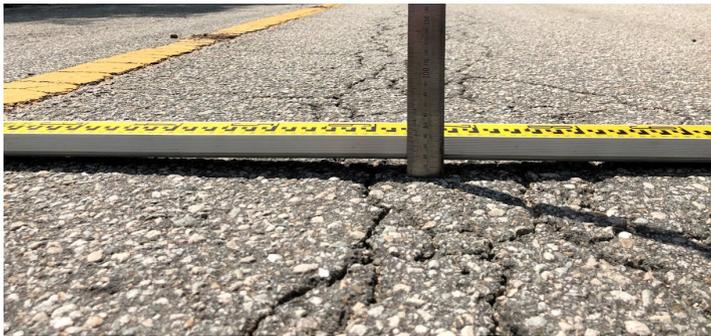
**Fig. 5.** Deformation and Fatigue Crack

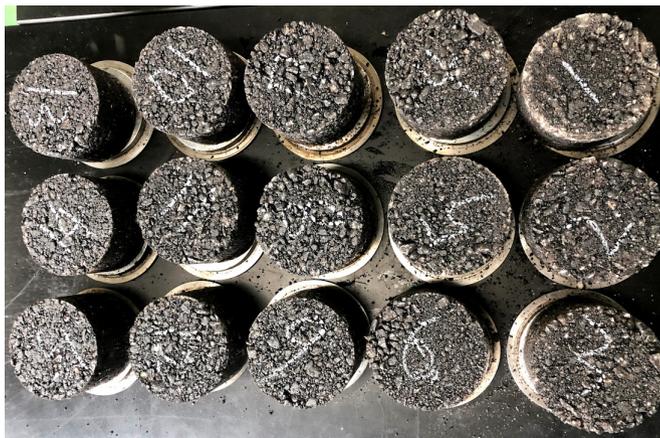
The Marshall samples were made after mixing the rejuvenator again into five types of content from 0 to 10%. All specimens show a defect in compaction, and the air void also exceeded the standard range of 3~6%. The amount of additives is on the decline as they become high. Nevertheless, overall Marshall stability values were high (approximately 1.5 to 2 times the typical new material mixture). It is estimated as the stability value does not fall and goes up due to the addition of additives is due to the increase in the compaction rate.

Specimens with an additive content of less than 5% have severely reduced aggregate debris on the surface and began to exhibit sticky viscosity at least 7.5% of the additive. However, since this phenomenon may be caused by lack of additives or lack of asphalt content in existing RAPs, additional confirmation is required. In this case, additional aggregate input and new asphalt are required besides additives.

**Fig. 7.** Specimens for Marshall Test

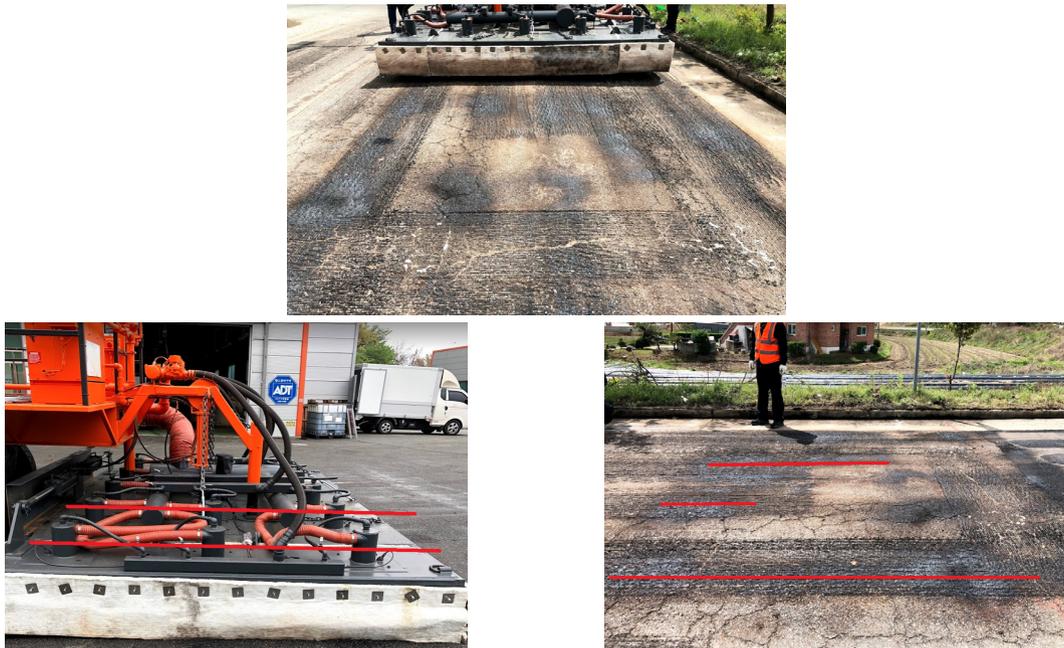
**Fig. 9.** Preheater road surface after heating

the range of 230 to 280°C on average immediately after preheating, but the surface was overheated by 350 to 380°C or more, including malfunction of the equipment, and the road was severely burnt by fire. In particular, the burners are arranged in a row rather than in a progressive direction, causing local overheating.

It is expected that it will be difficult to control the direction to move on roads with narrow width, acceleration, and linear sections due to difficulties in adjusting heater plate width and the equipment that will monitor in real time is needed due to difficulties in checking surface heating temperature and road conditions.

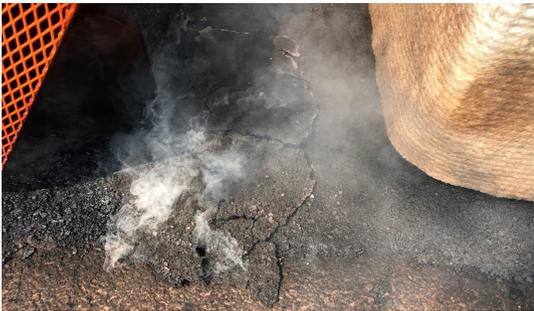
It was possible to cut the depth of 3 to 5 cm in the overheating section, but the average cutting depth of the normal heating section was measured from 2 to 3 cm. After cutting, the surface temperature was measured at 70°C to 90°C, and the surface of the cutting surface was rough.

**Fig. 10.** Overheating Area before Cutting

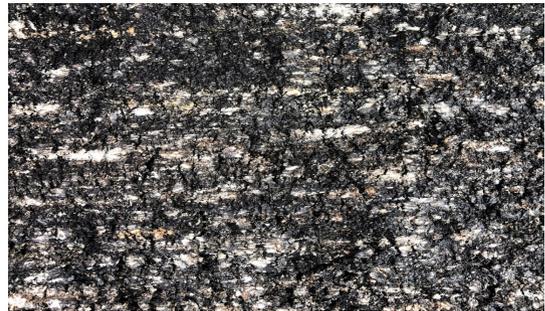
The thickness of the existing surface layer in this section (3~4 cm) is so thin that coarse aggregate for the base layer is hung on the blade. If only 2~3 cm surface is removed from the sufficiently heated section, the cutting side is in smooth condition.

**Fig. 11.** Blade Cutting Side

- Cutting depth of the blade is limited to 2 ~ 3 cm at the normal operating section of the equipment. At partial overheat section, 3 ~ 5 cm is possible, but when cutting 3 ~ 5 cm, coarse aggregate of the lower mixture is hanging on the blade sometimes. Cutting depth needs to be considered carefully.

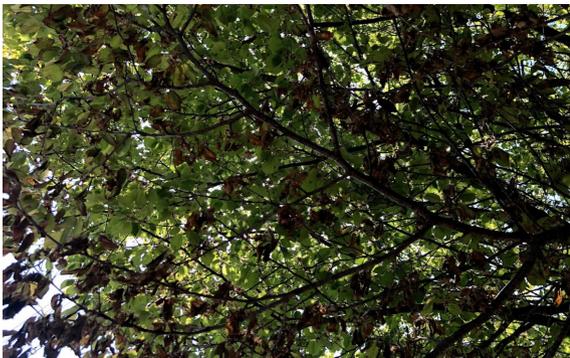
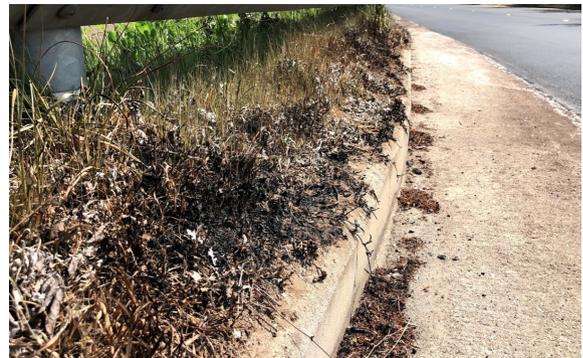
As the surface temperature outside the heating line of the heater was heated up to 180°C, roadside trees and the concrete structure such as the L-type gutter were partially damaged. Additional measures such as heat-protecting panel will be needed to reduce the damage of trees and plants on the roadside.

**Fig. 12.** Damage to Roadside Trees and Structures

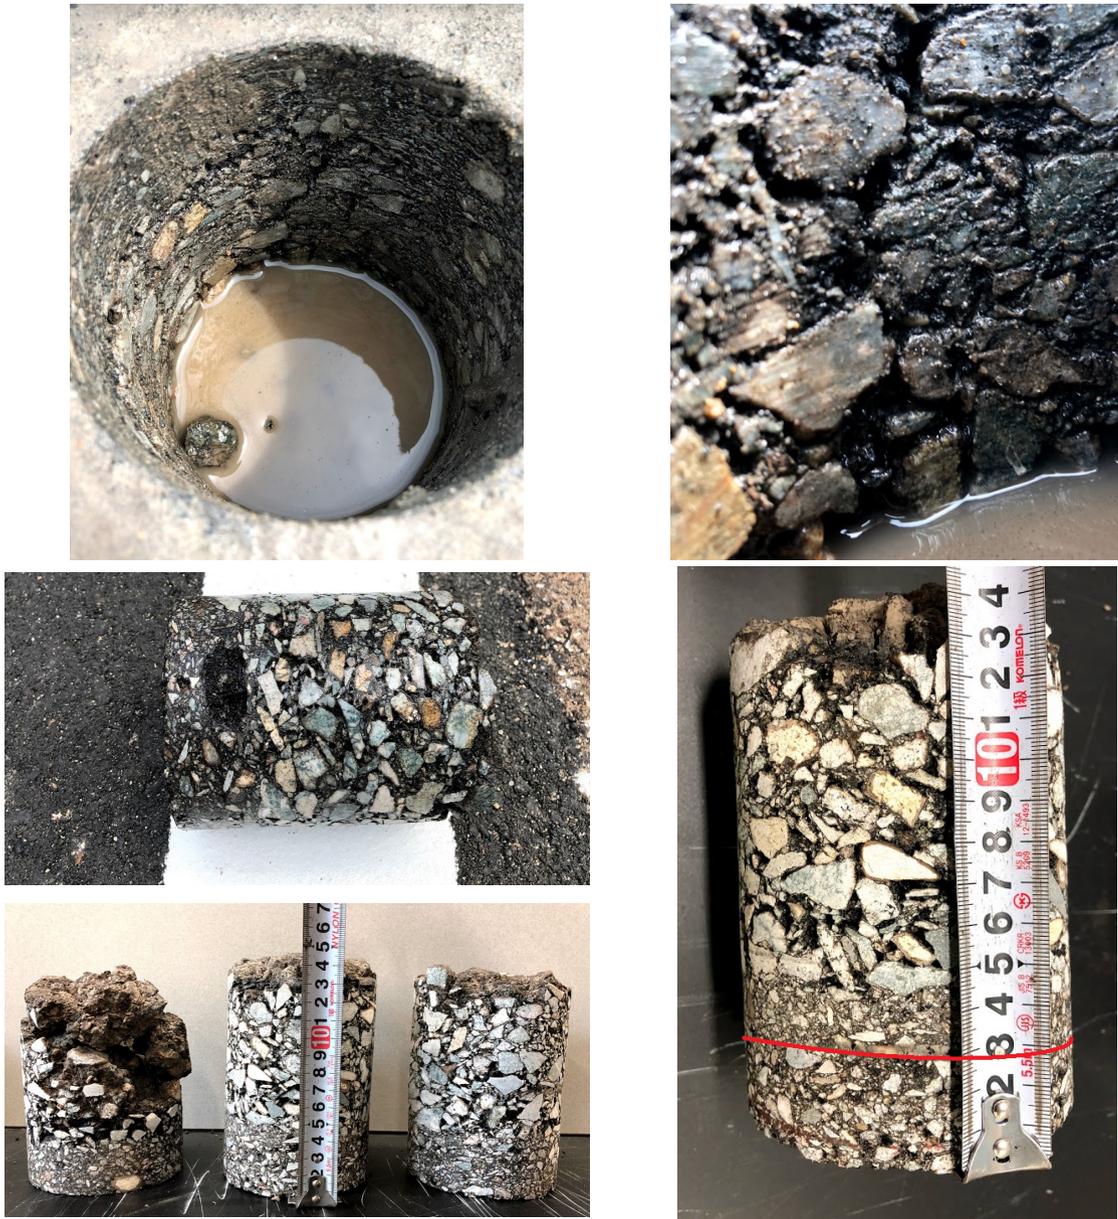
After completion of the compaction, the newly recycled layer was completely bonded to the existing layer so as not to be distinguished from the existing layer. In some cores, a carbonized mixture was found to be broken after core picking.

Influence of the heater on the lower layer (base course) was not confirmed.

Fig. 14. Field Cores after Construction
