# Technical report on 100% hot-in-place asphalt recycling trial pavement

- Project Name: The Re-pavement Construction of Cheongan Samgeori-Cheongan Bridge on County Road Line 1 (Goesan County, Chungbuk, Korea)
- Scale of construction: 2,236.5 m<sup>2</sup> of road retreatment pavement
- Extensions and road width : L = 355 m, W = 6.3 m
- Thickness of pavement : T = 15 cm (base 10 cm + surface 5 cm)

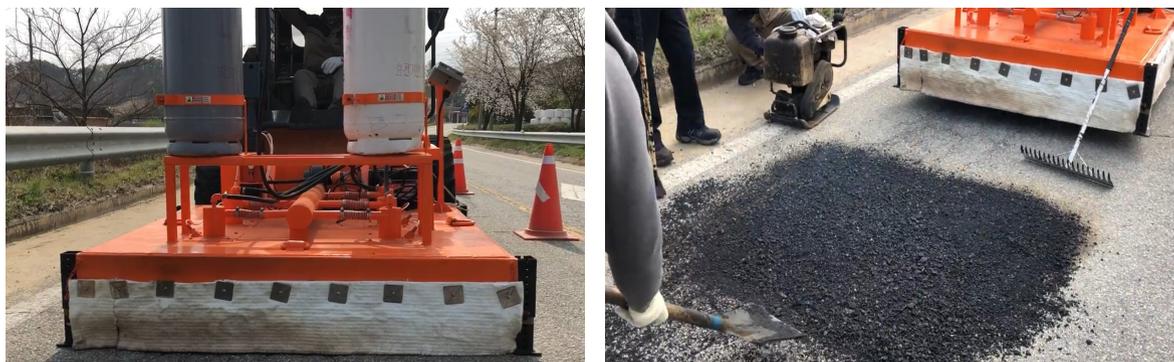
**Fig. 6.** Hot Spot Equipment & Sampling

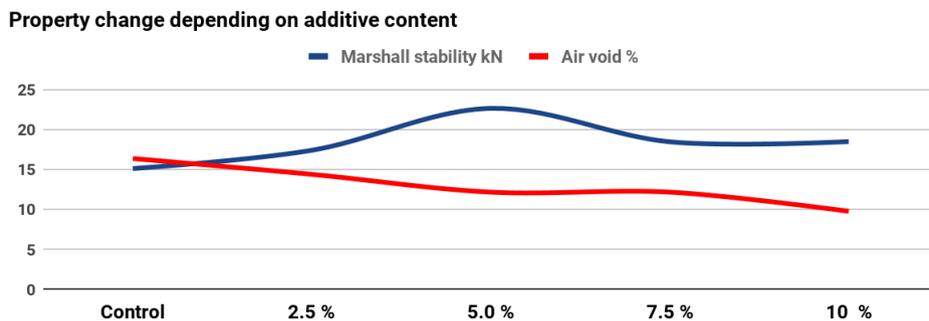
The Marshall samples were made after mixing the rejuvenator again into five types of content from 0 to 10%. All specimens show a defect in compaction, and the air void also exceeded the standard range of 3~6%. The amount of additives is on the decline as they become high. Nevertheless, overall Marshall stability values were high (approximately 1.5 to 2 times the typical new material mixture). It is estimated as the stability value does not fall and goes up due to the addition of additives is due to the increase in the compaction rate.

Specimens with an additive content of less than 5% have severely reduced aggregate debris on the surface and began to exhibit sticky viscosity at least 7.5% of the additive. However, since this phenomenon may be caused by lack of additives or lack of asphalt content in existing RAPs, additional confirmation is required. In this case, additional aggregate input and new asphalt are required besides additives.

**Fig. 8.** Property Change Graph

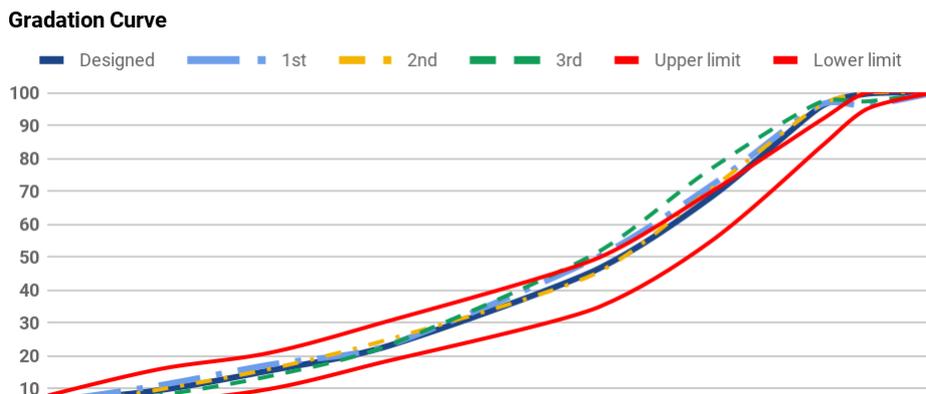
**Fig. 13.** Gradation Curve

The maximum size of the extracted mixed aggregate was within 9.5 mm, but the granularity distribution showed a (internal flow) form of the coarse aggregate with more than 0.25 mm. In addition, there was a high ratio of rag stone of the aggregate between 4.75 and 0.25 mm in the extracted aggregate. These factors may have facilitated fatigue cracks at the site.

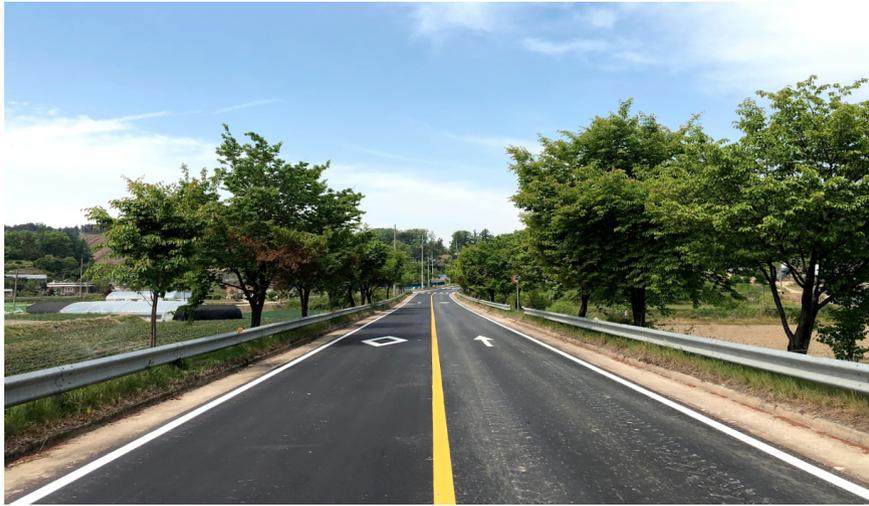
**Fig. 16.** After Construction

- Bonding between the existing pavement layers and the bonding of the construction joint are observed to be excellent. However, distortion at the end point (insufficient mixture) and step difference occur.

- The field compaction rate is over 98%, which makes it possible to secure good pavement quality, but smoothness seems to be insufficient.
